An Evaluation of Shearography and Neutron Radiography for the Non-Destructive Inspection of Helicopter Main Rotor Blades

Markus M. D. Coetzer
Defence Aeronautics Programme
Defencetek, CSIR
Meiring Naudé Road
Brummeria
0184

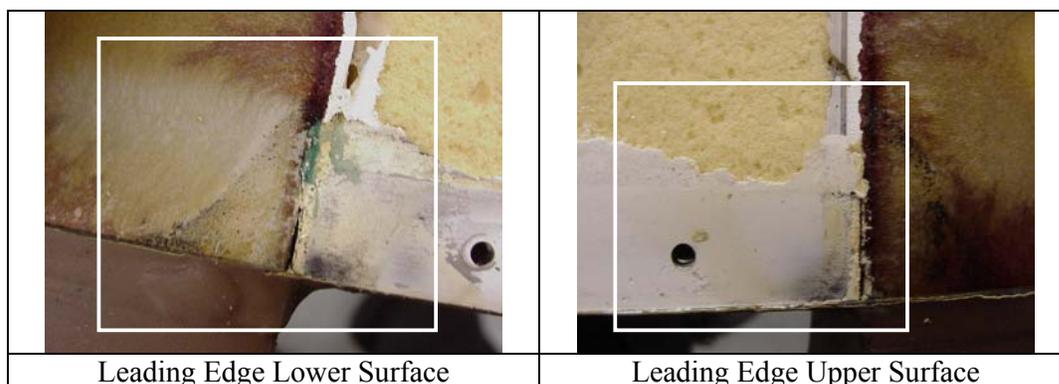
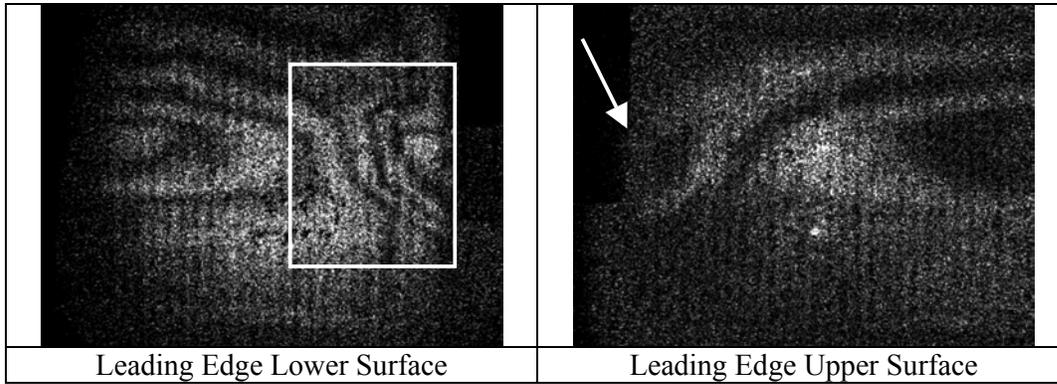
Of the twenty delaminations found in the area of the leading edge of the blade, shearography successfully detected eighteen (Fig. 1).

Figure 1: Successful detection of delamination in the area of the leading edge.

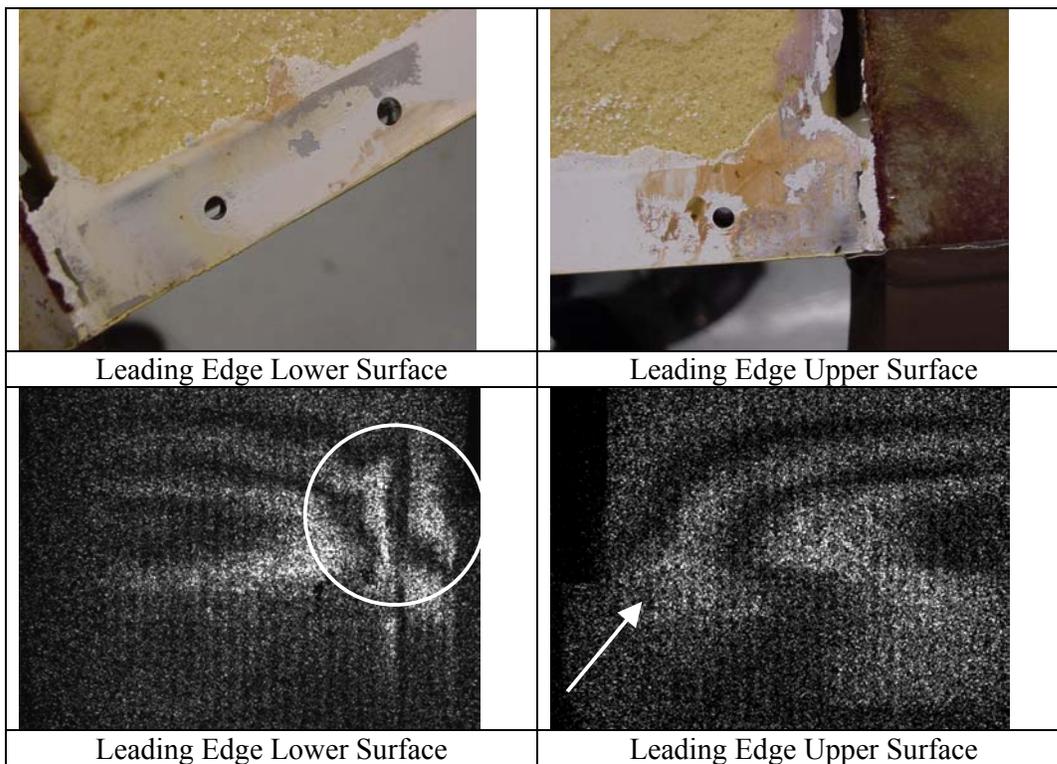
Of the other eleven defect indications obtained six may be explained as being due to the presence of previous repairs in the area, two by the presence of oil (Fig. 2) and three are unknown.

Figure 2: False indication due to presence of an oily substance in the area of the leading edge.

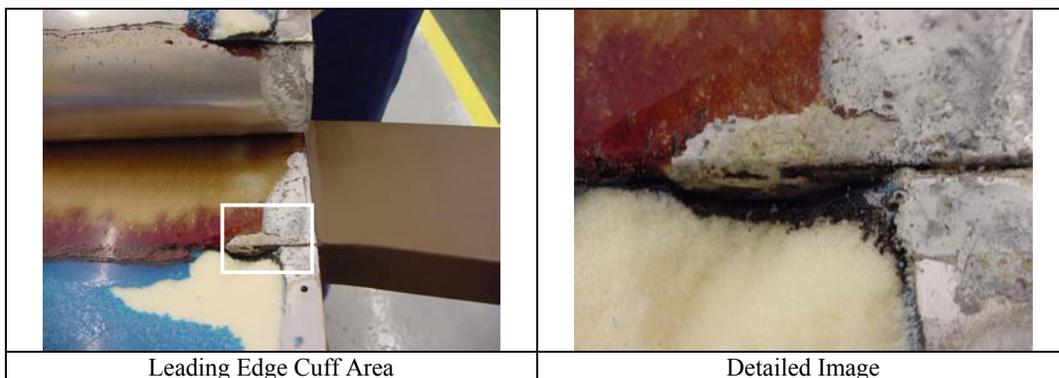
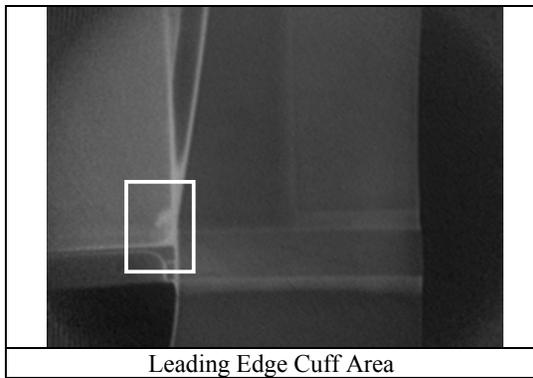
Of the ten instances of corrosion found neutron radiography successfully detected five (Fig. 3) and showed no obvious defect indications for the other four. The final instance was outside of the area inspected.

Figure 3: Successful detection of corrosion in the area of the blade cuff.
