The Application of Optically-based NDE Techniques to Flaw Detection in Aircraft Components

D.J. Reid Rowland, D. Findeis, J. Gryzagoridis

University of Cape Town, Private Bag, Rondebosch, 7700, South Africa
dave_reid_rowland@hotmail.com, dfindeis@eng.uct.ac.za, profg@eng.uct.ac.za

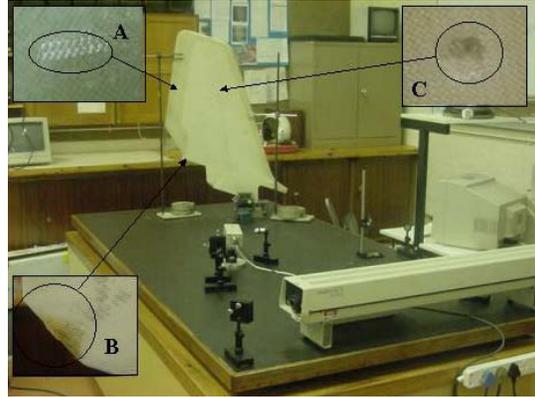
Figure 4 ESPI Testing of fin

The aircraft fin tested was a fibreglass/epoxy composite, and was in an as-manufactured state. ESPI was used to investigate several possible manufacturing flaws (marked A). These included air inclusions in the structure and areas where the epoxy had not bonded well to the fibreglass. Other flaws were also investigated such as a delamination (marked B, approx. 20x20mm) and an impact damage area

(marked C, approx. 6mm diameter). A hair dryer and spotlight were used to create thermal stresses in the object for the investigation. By varying where the heat was applied, various different effects were noticed. When heating the area under investigation directly, fringes were created as a result of thermal expansion of the surface. Because of a disruption in heat flow around a flaw, differential isotherms were created in this region, and hence differential expansion. By heating indirectly from the opposite side of the fin, thermal expansion gave rise to mechanical stresses around the flaw.

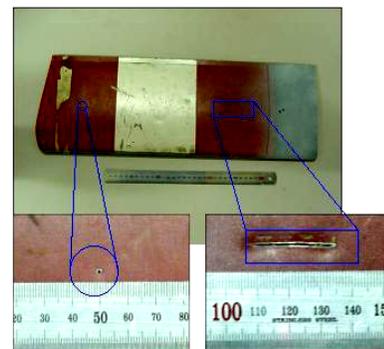
Figure 5 Tail rotor with flaws

A helicopter tail rotor section was also tested using the same procedure. It had two artificial flaws created on its surface, namely a pinhole (approx. 1mm diameter) and a slit (approx. 20 x 0.5mm). The slit was designed to simulate a crack in the blade surface

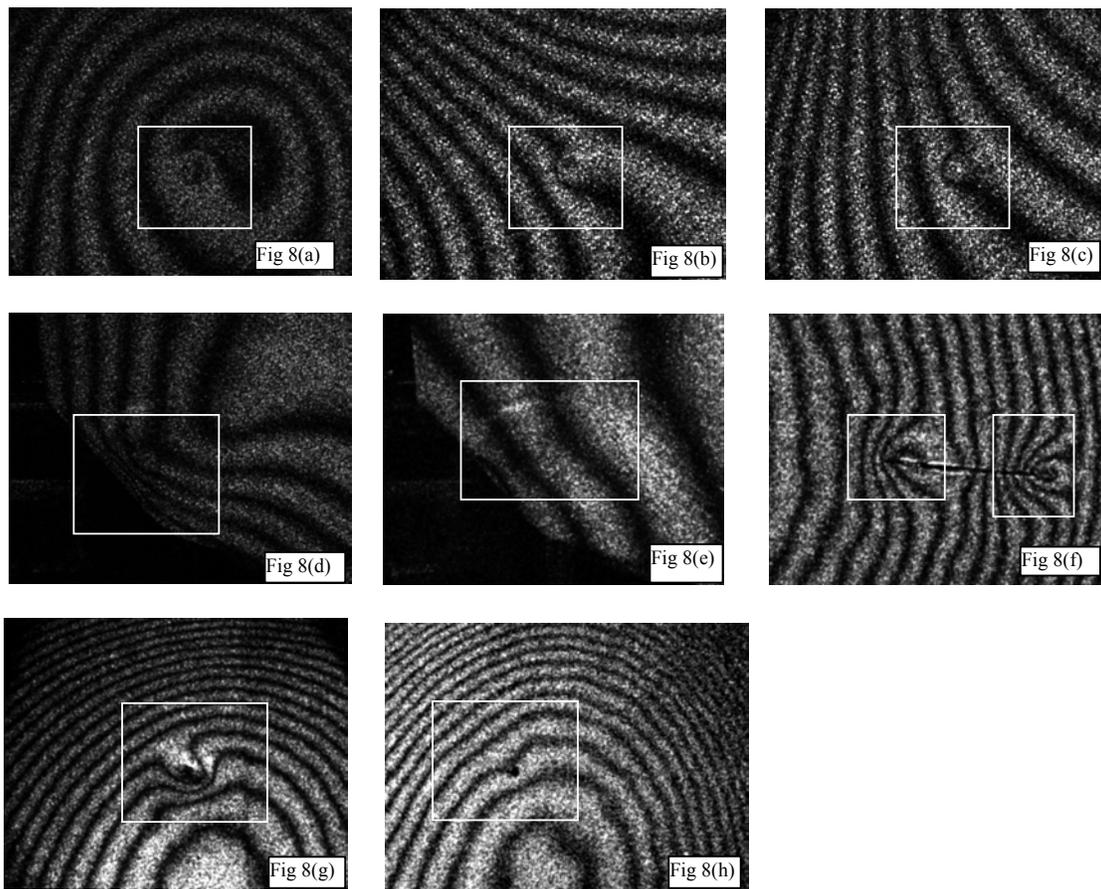
Figure 8 ESPI results

The ESPI did not indicate any structural defects when testing flaws present from manufacturing that were visible on the object surface. The induced flaws were however easily located. Figure 8(a) shows the ESPI image of direct heating on the impact damage area, highlighted by the irregular fringe line. Figure 8(b) shows the ESPI image of the impact damage area stressed by heating the fin away from the flaw and figure 8(c) heating on the opposite side of the fin. Figure 8(d) shows the ESPI image of the delaminated region stressed by local heating and figure 8(e) mechanical stresses. Figure 8(f) shows the slit flaw in the tail rotor stressed by localised heating. Figure 8(g) shows the ESPI image of an internal flaw located by ESPI. This was not visible on the rotor's surface, and was located during ESPI inspection of the blade. Figure 8(h) shows the ESPI image of the pinhole flaw that can be seen as a result of the irregular fringe pattern.

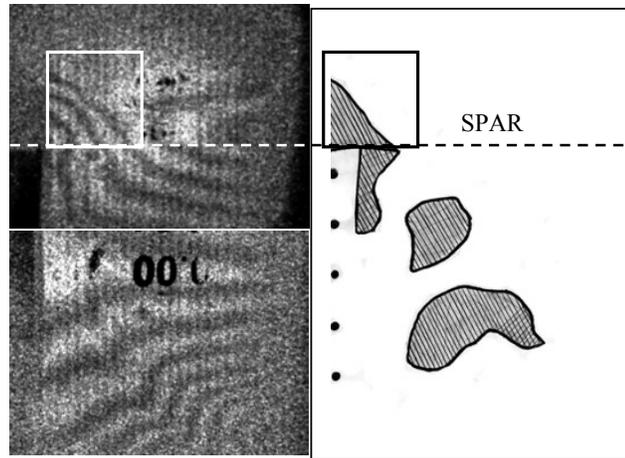
Figure 9 Shearography and MIA results for blade 14546

The shearography pattern in Figure 9 shows fringes in the spar area that are closely arranged and irregular, and is a possible indication of a flaw being present. The MIA and shearography scans appear to correlate for this flaw. There were two flaws in the middle and lower right of the MIA scan that were not detected by shearography. These would most likely have been debonding

between the outer skin and internal moltoprene filling.

In the lower shearography image of the trailing edge, the irregular fringe pattern marks the location of an alloy reinforcing rib on the blade. It shows up because of differential heat flow in this region compared to other areas of the blade.

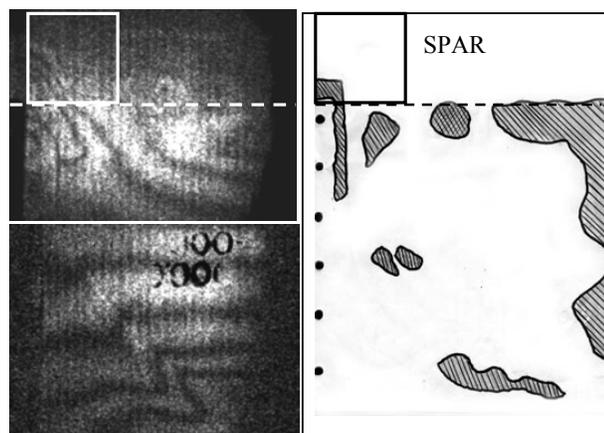
Figure 10 Shearography and MIA for blade 7093

In a subsequent test, both the MIA and shearography indicated a flaw near the spar. This is shown by the irregular fringe pattern in Figure 10 in the upper left area of the shearography image. Flaws indicated by MIA behind the spar were not indicated by shearography, although this is not critical, as these flaws are between the moltoprene foam and outer skin, which is not a structural part of the blade.

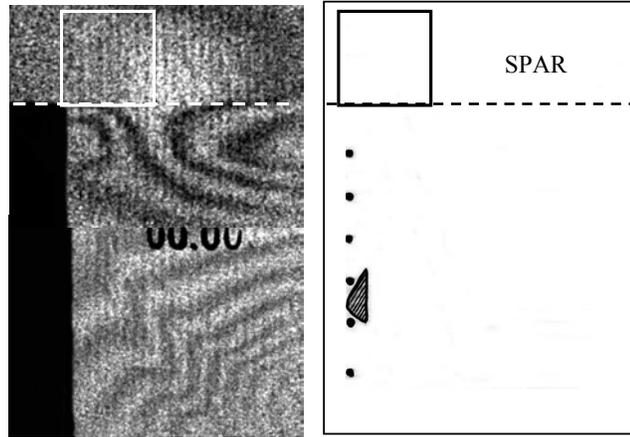
Figure 11 Shearography and MIA for blade 14460

MIA on this blade did not indicate a flaw near the spar. There were no fringes in the spar region of this blade. This was because the heat in this region had already been dissipated into the spar itself through the good bond between the outer skin and the steel spar. If there was a delamination between the spar and outer skin, a void would exist between them, and the heat

would not be able to dissipate as quickly, and fringes would be observed in this area. The peculiar pattern below the highlighted area is localised around a rivet. A possible flaw is indicated, which maybe a debond or loose rivet at this point. Again the kinked fringe in the trailing edge region is as a result of the reinforcing rib.
