THE USE OF ULTRASONIC TIME OF FLIGHT DIFFRACTION (TOFD) NDT AND FRACTURE MECHANICS FOR ACCURATE SERVICE LIFE PREDICTION OF A CARDEN SHAFT

R B Tait*, J Press** and Z McCann***

ABSTRACT

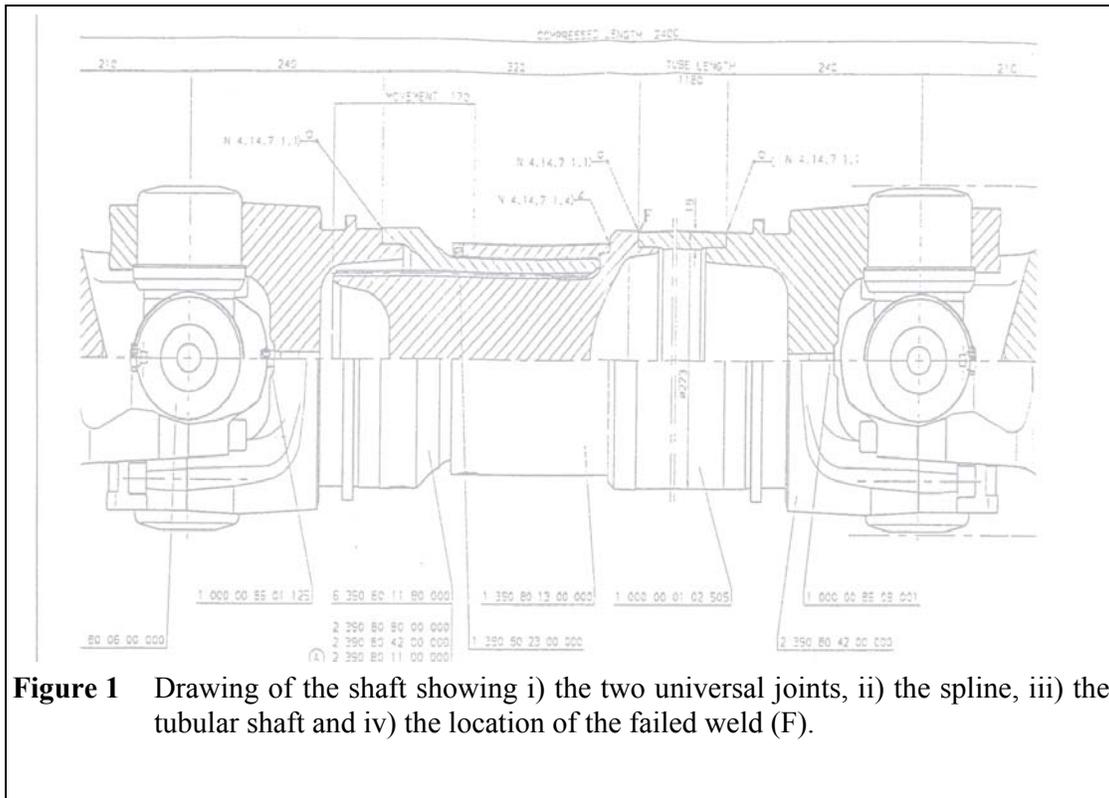
This Cardan shaft with a 2.5 metre operating length consisted of two universal joints, with forged yokes, welded on to either end of a splined tubular shaft, Figure 1. After two years and four months in operation the shaft failed at the weld, labelled ‘F’ in Figure 1, joining the forged end of the spline to the tubular shaft.

Figure 1 Drawing of the shaft showing i) the two universal joints, ii) the spline, iii) the tubular shaft and iv) the location of the failed weld (F).

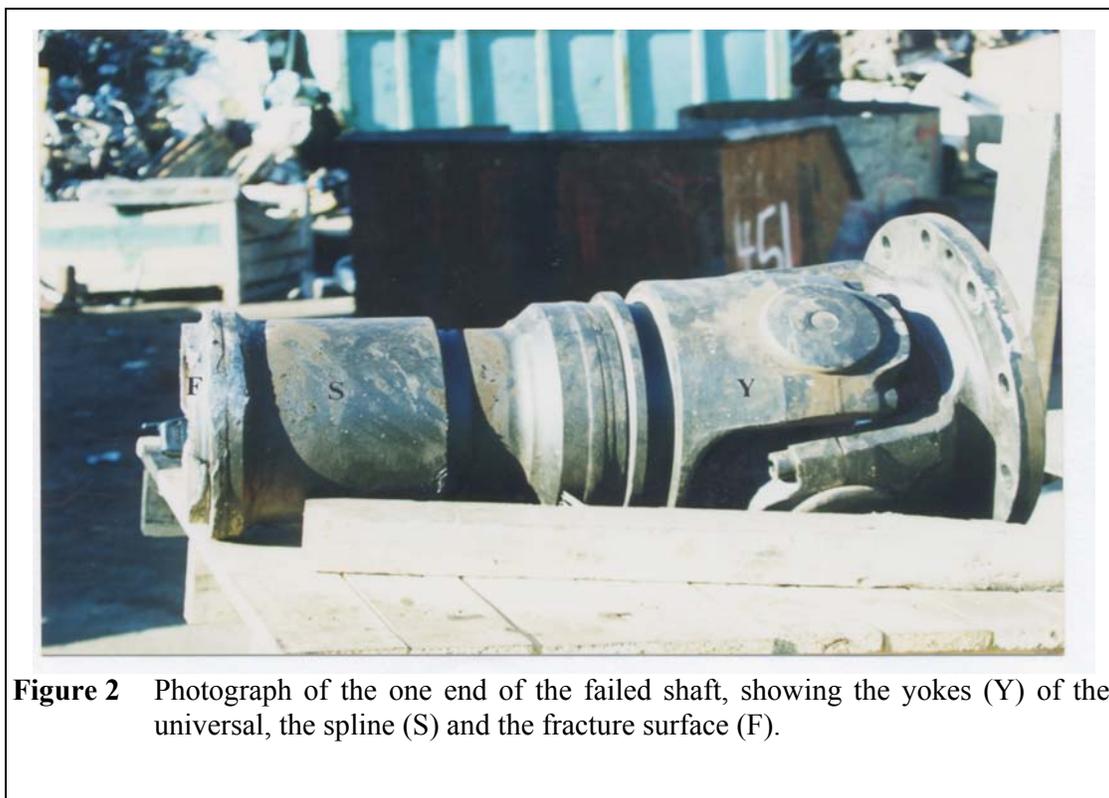
The shaft had fractured at the weld joining the forged end of the spline to the tubular shaft breaking the shaft into two pieces approximately 770 and 1630 mm long, Figure 2 and Figure 3 respectively.

As depicted in Figure 2 and Figure 4, the shaft had failed in the region of the shoulder between the spigotted end of the male part of the spline. Figure 2 and Figure 4 also show that the fracture surfaces had suffered secondary mechanical damage as a result of the failure - probably caused by contact between the end of the shaft and the reinforcing ring that had been installed in the wall between the motor and the shredding plant. Clear so called 'clamshell' markings, characteristic evidence of fatigue, were evident on the fracture surfaces, Figure 4 and Figure 5. These 'clamshell' marks were orientated at approximately 45° degrees to the axis of the bearings in the yokes indicated by the dashed line in Figure 4.

Figure 2 Photograph of the one end of the failed shaft, showing the yokes (Y) of the universal, the spline (S) and the fracture surface (F).

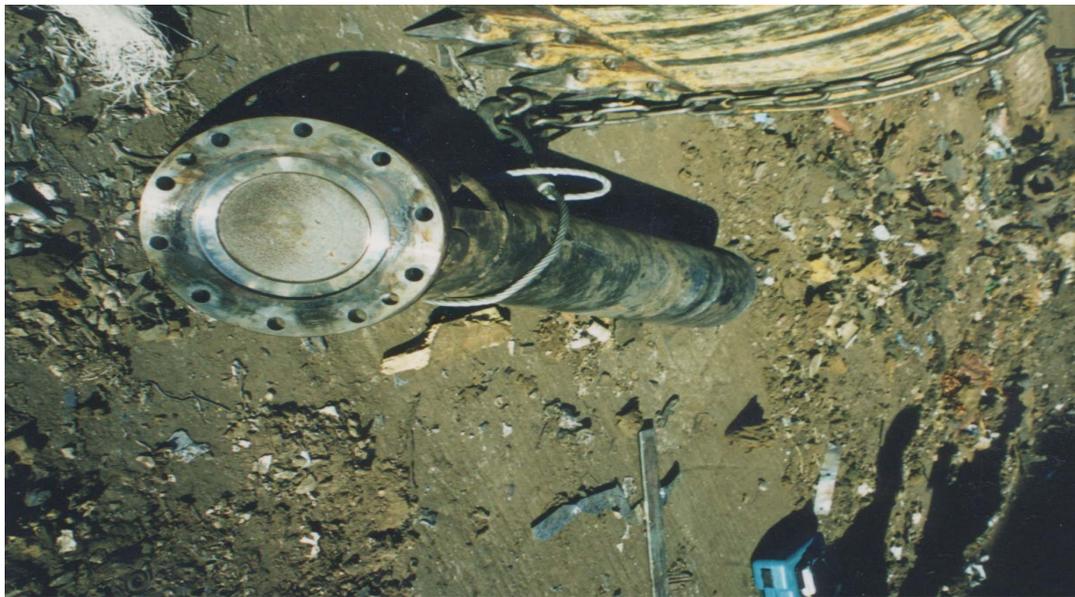
Figure 3 Photograph of the other end of the fractured shaft.

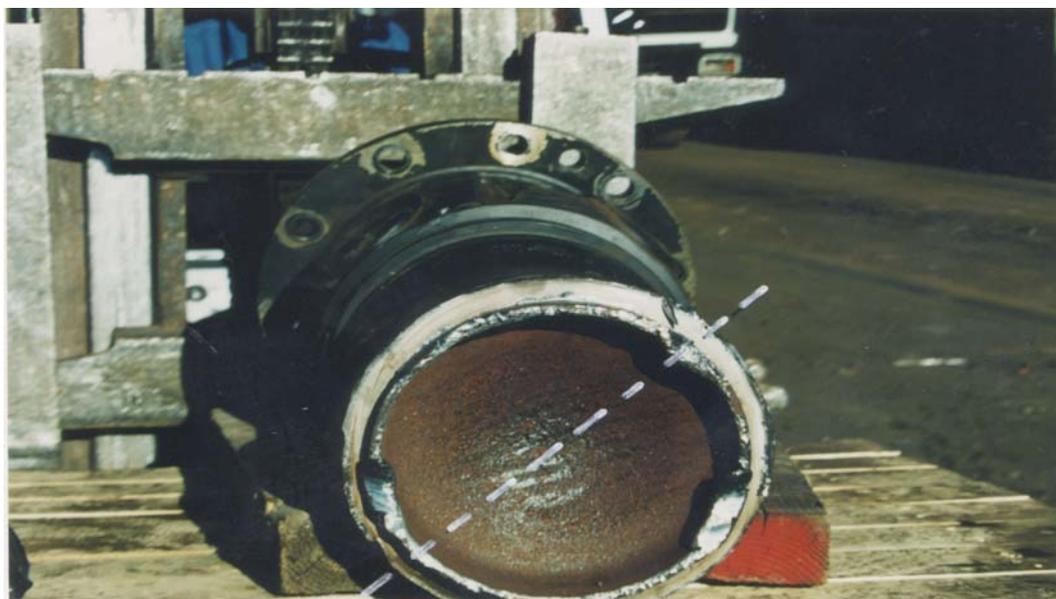
Figure 4 Photograph of the fracture surface of the end of the shaft shown in Figure 2. Evidence of so called 'clamshell' markings, characteristic evidence of fatigue, orientated at approximately 45° (when viewed from down the shaft) to the axis of the yoke (white dashed lines) are clear.

The ~45° orientation of the fatigue initiation points, as manifested by the clamshell markings, shows that the failure was probably influenced to some extent by the moments introduced in the shaft through the arms of the yoke. The stresses associated with these moments were not rigorously analysed (using finite elements, for example), however, a preliminary analysis of crack growth and fatigue life showed that failure by fatigue mechanisms was entirely plausible under the sole action of the torsional load cases identified in the GEC report, and

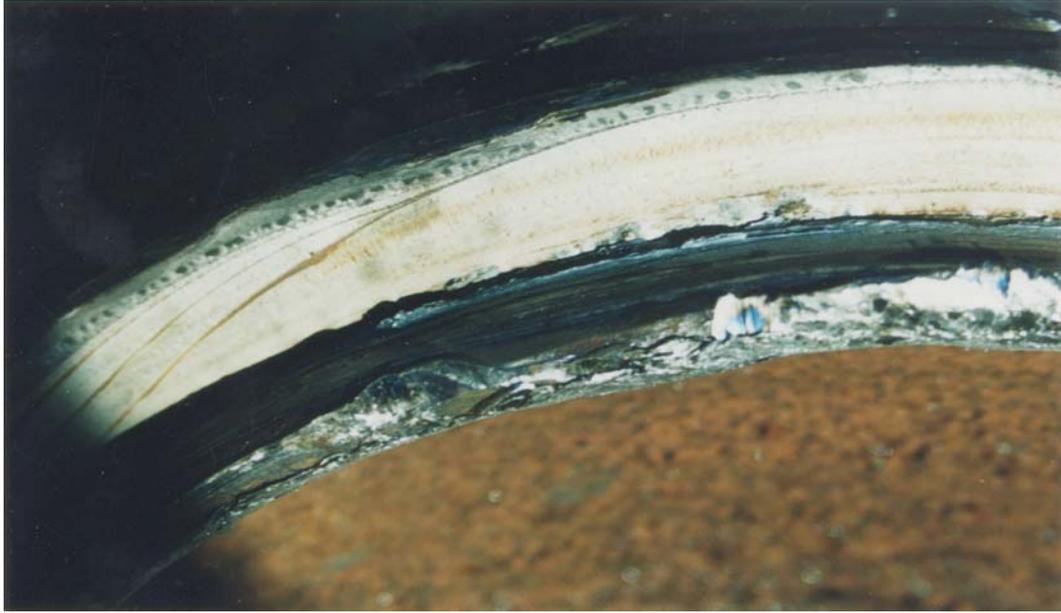
Figure 5 Close up photograph of the fracture surface of the end of the shaft shown in Figure 4. So called 'clamshell' markings and a variation of their orientation was clearly evident.

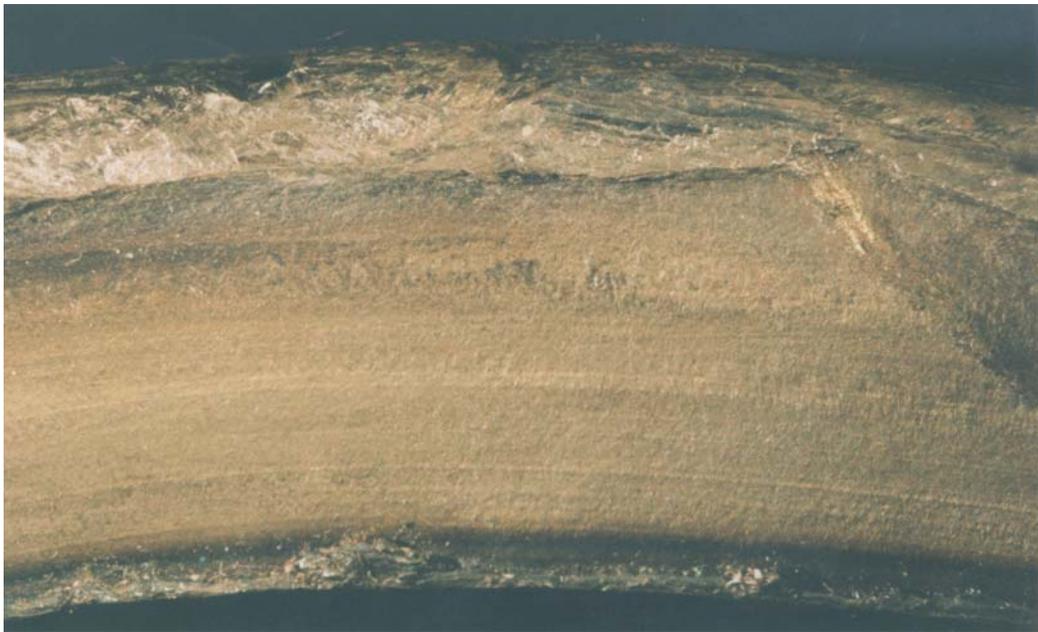
Further clear evidence of 'clamshell' markings was highlighted during the microscopic investigation, Figure 6 and Figure 7. Figure 6 furthermore shows the relatively greater degree of roughness of the outer regions of the fracture surface - which indicated that these outer regions were the areas of final fast fracture - which in turn implied that the crack initiated at the inner surface and propagated outward. The crack also propagated in the region of the interface of the weld heat affected zone (HAZ) and parent plate. This was further confirmed by areas indicative of the rapid failure of weld material near the outer regions of the fracture surfaces, Figure 8. These figures also show that the shaft had fatigued over the majority (between 70 and 90% depending on location) of the section thickness before final failure occurred. This indicates that both the cyclic and the mean stresses were low - but just high enough to cause fatigue in the presence of a stress concentrating feature.

Figure 6 Micrograph (4.75x magnification) of the fracture surface of the end of the shaft shown in Figure 3 showing further evidence of 'clamshell' markings.

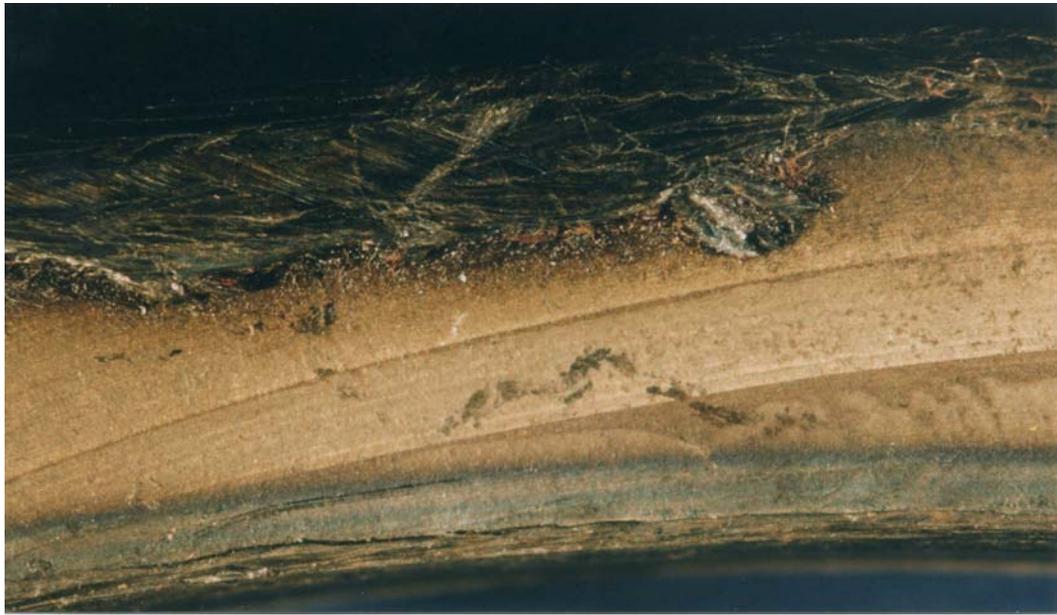
Figure 7 also shows a region of discoloration at the inner surface of the shaft. It is believed that this discoloration was caused by the overheating of the shaft (due to friction)

in the period just after final failure prior to the hollow shaft disengaging from the spigot at the end of the splined section.

Figure 7 Micrograph (4.75x magnification) of the fracture surface of the end of the shaft shown in Figure 3 showing evidence of 'clamshell' markings in another region of the shaft. In comparison to those in Figure 6, a change in orientation of the 'clamshell' markings is clearly evident.

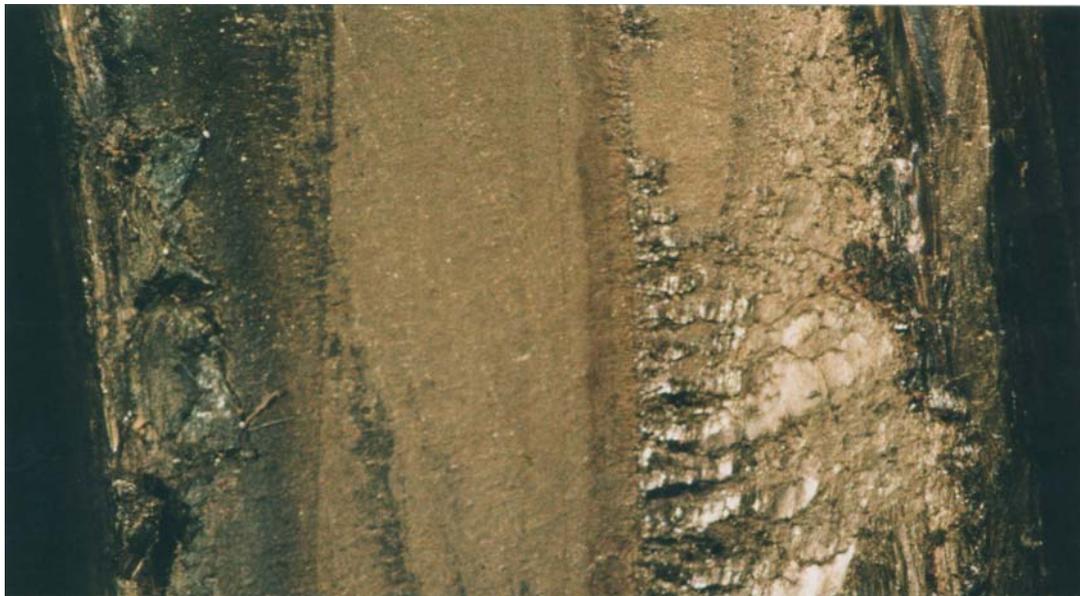
Figure 8 Micrograph (10x magnification) of the fracture surface of the end of the shaft shown in Figure 3 showing evidence of 'clamshell' markings as well as areas of fast fracture with an appearance consistent with that of fast fracture of dendritic crystalline weld material near the outer diameter of the shaft (right).

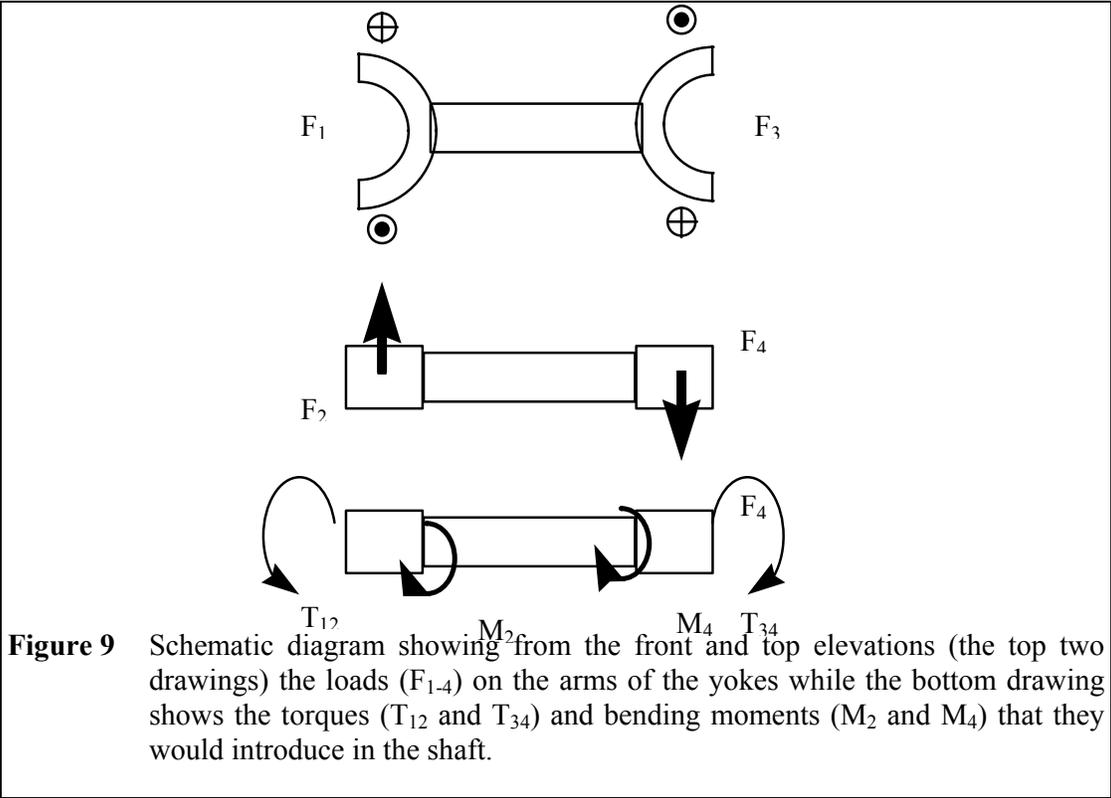
An additional complexity is introduced by the bending moments introduced into the shaft through the arms of the yokes, M_2 and M_4 , Figure 9. These moments and their effects are most easily visualised using a ring or section of flexible tube, and loading it with the moments as illustrated in Figure 9 and Figure 10. These moments that act in the plane of curvature of the shaft. (i.e. opposite sides of the curved surface) and fluctuate at twice the rotational frequency due to the fluctuation of loads F_1 and F_2 . Under the influence of these moments the shaft tends to distort from its circular section into an oval one orientated $\sim 45^\circ$ to the axis of the yokes, Figure 10. This distortion therefore introduces additional fluctuating stresses which have a maximum at $\sim 45^\circ$ to the axis of the yokes, that fluctuate at twice the rotational frequency. As the moments also cause distortion, which takes the form of a ‘double S’, in and out of the plane of Figure 10, they would also have tended to induce a relative axial movement in the material of the shaft. Analysis of the magnitude of these stresses is complex and a full detailed analysis would have required finite element techniques which, although possible, was considered to be beyond the scope of this present investigation.

Figure 10 Schematic diagram illustrating the effect of the distortion, as seen from the axial elevation, caused by the bending moments M_1 and M_2 that would have been introduced into the shaft through the arms of the yoke.
