Structural Defects

Structural Defects in Electrically Degraded 4H-SiC pin Diodes

Propagation of Current-Induced Defects and Forward Voltage Degradation in 4H-SiC PiN Diodes

Optical Emission Microscopy of Structural Defects in 4H-SiC PIN Diodes

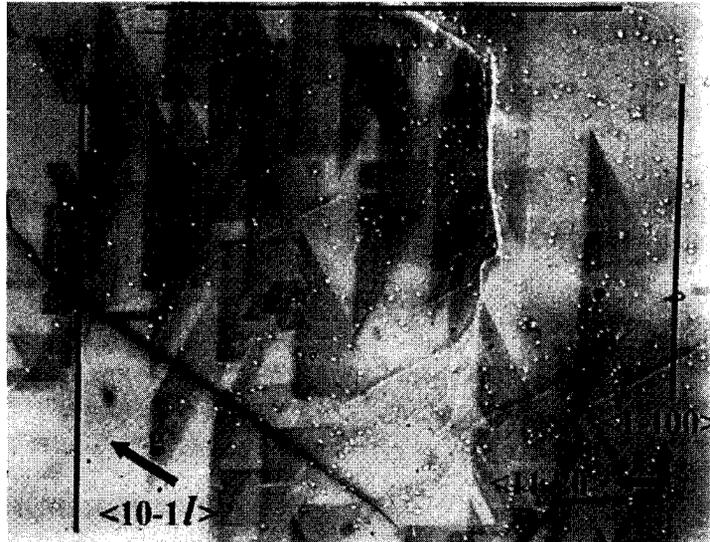
Figure 1. This image was recorded from a reflection towards $\langle 10\bar{1}0 \rangle$. The diode edges are outlined and a dark contrast appears in the area of the triangular stacking fault.

Figure 1 displays a back-reflection topograph obtained from a reflection towards $\langle 01\bar{1}l \rangle$ of a degraded diode (edges outlined) as recorded by SWBXT. This image outlines triangular areas of dark contrast which are interpreted as stacking faults.

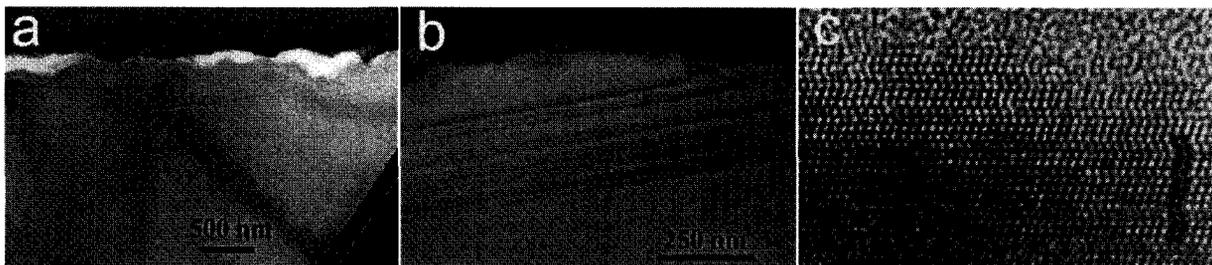
Figure 2. TEM image of the sample prepared by FIB. A straight line corresponding to the stacking fault runs through the crystal in a) and in b) this set of stacking faults was found. A high resolution TEM image of the defect is finally shown in c).

Figure 2a shows a TEM image of a cross-sectional sample prepared by FIB. The picture was taken in a condition where the SiC $\langle 1\bar{1}00 \rangle$ crystal zone-axis was parallel to the electron beam. The straight line seen in Figure 2a makes an angle of about 8° with respect to the surface. This shows that the defect is a stacking fault residing on the SiC basal plane. Figure 2b shows another area of the sample where also sets of parallel stacking faults were present. A defect was studied by high-resolution electron microscopy and the results are shown in Figure 2c. The image was obtained by orienting the $\langle 2\bar{1}\bar{1}0 \rangle$ zone axis in a condition so as to be parallel to the electron beam. It can be seen that the 4H stacking sequence ABACABAC is replaced by ABCBCACB.

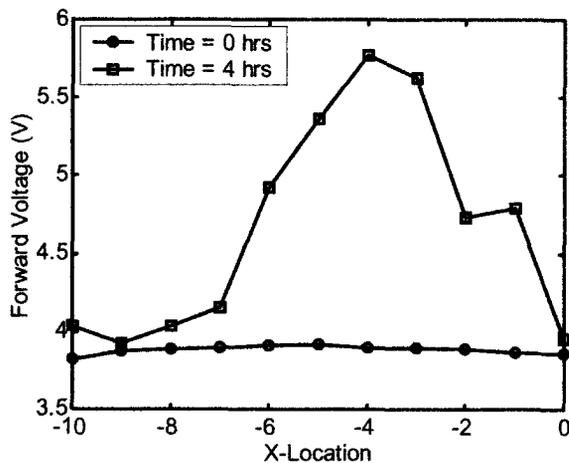
Fig. 1 PiN diode forward voltage versus time at various locations at a constant current of 0.5 A.

The characteristics of defect propagation have been examined by combining electrical measurements with optical imaging of the defects. Two striking features were that the degradation of diodes on the same wafer can vary by an order of magnitude and that the degradation varied smoothly as the wafer is traversed. Long-term electrical test data from a row of diodes from wafer center (0,0) to wafer edge (-10,0) are shown in Fig. 1. These devices have an anode with a continuous metal overlay. At room temperature, with a stressing current of 0.5 A (80 A/cm^2) the voltage degradation ranged from 0.2 to 2 V. The voltage increase with time for this set of diodes is shown in Fig. 2. While the magnitudes of the voltage increases were very different, all exhibit the most rapid increase within the first few hours and changed much less slowly after 5 hours. Fig. 3a-f shows a sequence of images for one of the window anode devices where the diode is held in forward bias at a constant current of 0.5 A (80 A/cm^2) at room temperature. The images show dark line features in the light emission, which appear within 20 minutes and propagate perpendicular to the primary wafer flat. After greater than 3 hours of constant bias, no further dark-line propagation was observed for this device. This time dependence is consistent with the forward voltage increase plotted in Fig. 1. Increasing the current to 1 A (160 A/cm^2) strongly accelerated the rate of defect formation.

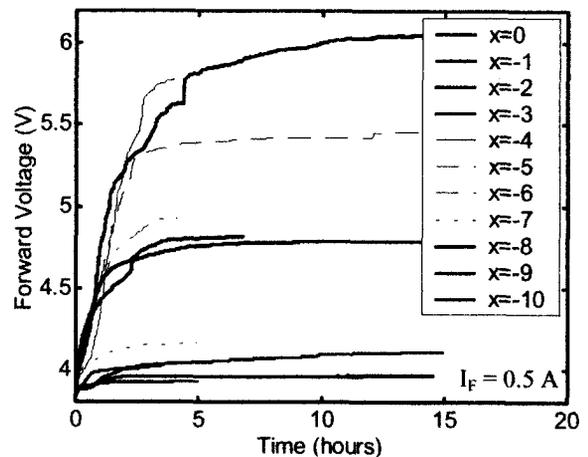
Fig. 2 PiN diode forward voltage versus position on wafer at 0 and 4 hours. The wafer center is denoted (0,0) and the edge as (-10,0).

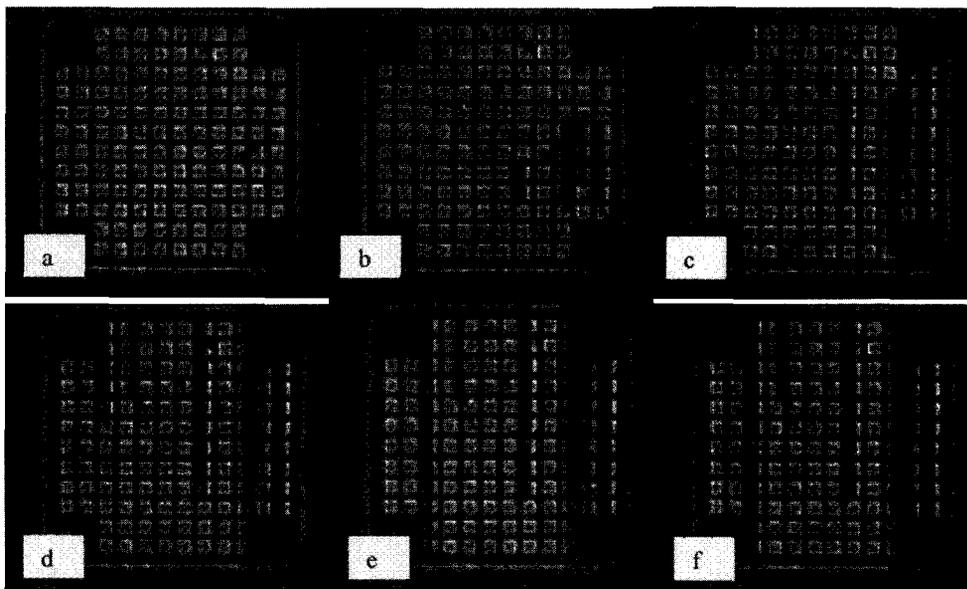
Fig. 3 Light emission from a PiN diode with anode windows at a constant current of 0.5 A at various time intervals (a) 0 hr, (b) 0.3 hr, (c) 1 hr, (d) 2 hr, (e) 3 hr, (f) 3.7 hr.

Based on our electrical results and time-lapse sequences of images, it is possible to make a number of observations about the degradation mechanism. The dark line features are attributed to a localized reduction of carrier lifetime caused by an extended defect, most likely a stacking fault [2]. In these regions of low carrier lifetime, the electron-hole plasma in the drift layer is suppressed, resulting in weaker light emission and lower current. Before current stressing few, if any, defects are observed. However, we assume that there are pre-existing and unobserved defects that are present and the density of these defects is not uniform. The identity of these pre-existing defects has not yet been determined. Based on the smooth variation of degradation observed in Fig. 1, the density of these defects appears to vary on a length scale on the order of a few mm. Once defects nucleate and start propagating, all have a similar growth velocity. This velocity strongly depends on the current. The defects grow in the $\langle 1100 \rangle$ direction and often grow until they span the diode. In other cases, growth abruptly stops as the growth front is pinned. During the operation of the diode, new dark line defects are continually being generated. Defect generation rates are greatest during the first minutes of operation. Initially, new defects are started at the highest rate. At longer times, when the electrical degradation has saturated, the rate of new defect starts is much lower. The growth dynamics of individual defects that start later do not appear to be different from those that start earlier.

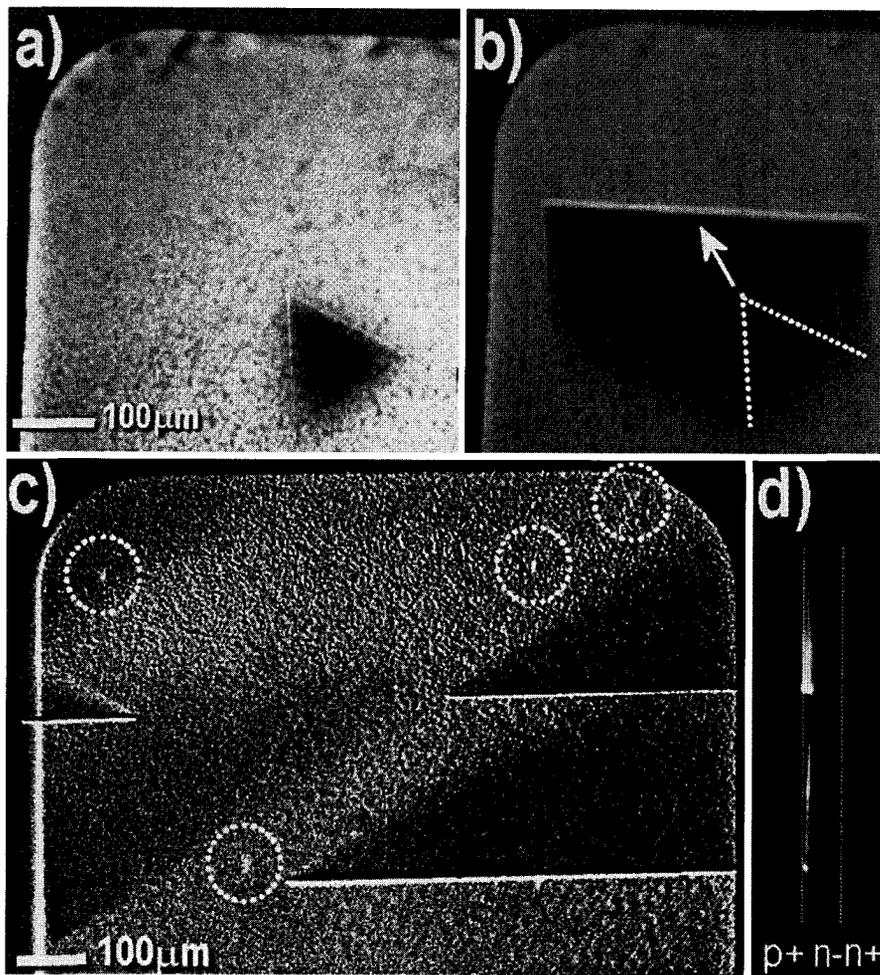
Fig. 1. Imaging of the EL emission from 4H-SiC $p^+/n^-/n^+$ structures: fast migration ($>50 \mu\text{m/s}$) of dislocation pairs across the active area of electrically stressed devices was observed in real time (a). This propagation seems to be terminated once a structural defect is met on the way, and an extensive planar defect with a characteristic bright-line edging is generated throughout entire epitaxial layer (b). An enhanced (cross-polarized) EL imaging was utilized to expose locations of the built-in strain fields around micropipes and screw dislocations (c). A cross-sectional imaging has provided both a 3D outline and spectral contents of emission solely from the stress-induced features (d).

We demonstrate that a successive imaging of emission from the investigated 4H-SiC PIN structures makes possible real time monitoring of the electrical stress related phenomena. In this way, a rapid migration ($>50 \mu\text{m/s}$) of dislocation pairs across the active area of devices was observed *in situ* using backside EL geometry. This propagation is presumably originated by thermal-stress and seems to be terminated once a structural defect is met on the way. An extensive planar defect with a characteristic bright-line edging is then generated throughout entire epitaxial layer. An enhanced, i.e., digitally processed cross-polarized EL imaging was utilized to expose the built-in strain fields around individual dislocations and to reveal the locations of micropipes and elementary screw dislocations. Interestingly, some of EL patterns indicate that these defects could also be responsible for the pinning of the further bright-line expansion. Finally, a cross-sectional imaging has directly provided a 3D outline of the stress-induced defects, indicating clear match with the basal plane. A spectral content of emission obtained solely from the stress-induced features is compared with the luminescence spectra from defect-free areas at different current densities and temperatures.

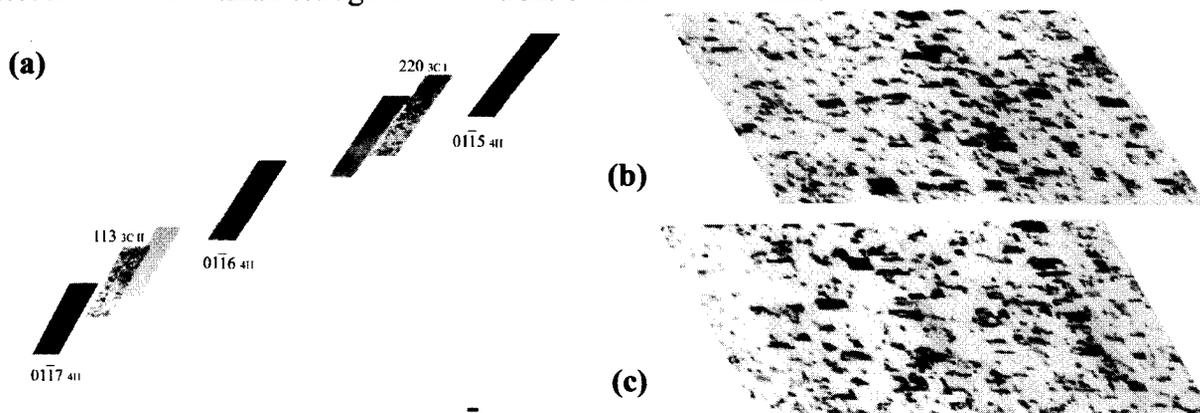
Figure 2(a) Selected area from reflection diffraction pattern recorded from wafer 1; **(b)** and **(c)** composite images showing the distribution of 3CI **(b)** and 3CII **(c)**. Colors were then assigned to these images and, following image processing to remove the geometric distortion, they were superimposed on Fig. 1(b), as shown in Fig. 3(a). Scale marks = 1mm

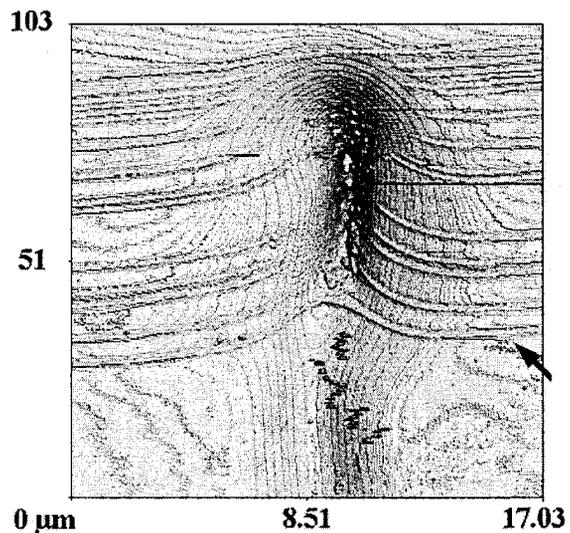
Fig. 1. AFM image of a trench-like defect extended from a micropipe. The arrow points to the steps.

The 4H-SiC specimen with a thickness of about 50 μm was grown by sublimation epitaxy at 1750C on Si-face, 8 degree off 4H substrate. Details of the growth geometry and procedure are described elsewhere [6]. From the AFM images, it was evident that in some cases the micropipes were related to a shallow trench at the surface as shown in Fig.1. The trench is always extended from the one side of the corresponding micropipe. The trenches coincide with the direction of the growth steps and they may extend up to 500 μm in length. In general the width of the trench corresponds to the diameter of the micropipe, the depth of the trench is between 30 to 140nm as measured by the corresponding profiles. Inside the trench the growth steps due to the lateral growth are distorted towards the direction of the pipe. Therefore the shallow trenches were related with a retardation of the steps due to the micropipe. It is worth noting that the steps are not broken in the trench, but they remain continuous.

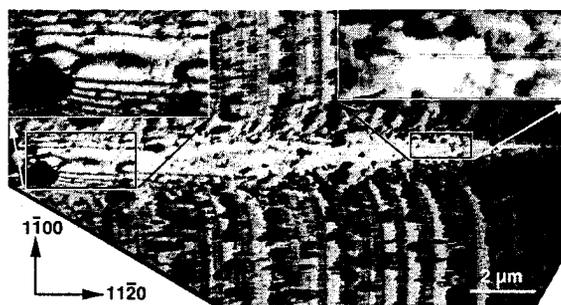
Fig. 2. TEM micrograph of the defect showing the bending of the steps and two insets with details.

The characterization of the trenches was completed by TEM observations. Due to the very large size (a few μm) and the very low density (10 to 100 cm^{-2}) of the micropipes it was difficult to locate the area of interest due to the very small field of observation provided by the TEM. Due to these limitations the specimen for the TEM characterization was prepared after location of the trench by the AFM. The area of interest was thinned only from the backside up to a thickness of about 200nm . The TEM micrograph including a part of the trench is shown in Fig.2. The bending of the periodic growth steps inside the trench is evident. In the inset in the left upper corner of the picture a magnified image of the origin of the defect is shown. The contrast of these fringes is attributed to surface ripple due to the step propagation and disappears when the specimen is thinned from the front side. The corresponding diffraction pattern from this area confirms the propagation of the trench along the $[1\ 1\text{-}2\ 0]$ direction.

A planar defect was also observed running inside the trench and parallel to its axis, as shown in Fig.2. The planar defect lies on the $(1\text{-}1\ 0\ 0)$ plane seen edge on in Fig.2. Details are shown in the upper right inset in Fig.2. In additional images it was evident that a dislocation can be found in the vicinity of the planar defect. We believe that this defect is a stacking fault, which is formed due to misalignment of the growth planes. In order to exclude the case of an artifact produced by a step parallel to $[1\ 1\text{-}2\ 0]$ direction the same specimen was thinned from the front side so that the growth steps and the trench were smeared out. The contrast of the planar defect persists revealing that it is related with the bulk SiC. The formation of the trench-like defect starting from pipes and extending along the flow direction of growth steps may be related to the high V_C/V_A ratio, where V_C is the normal growth velocity and V_A is the tangential component. Synchrotron X-ray topographs reveal dark contrast associated with the defect which might suggest that stress is present during the layer growth. Additional information regarding the relation of the planar defect with the slip trace will be presented.

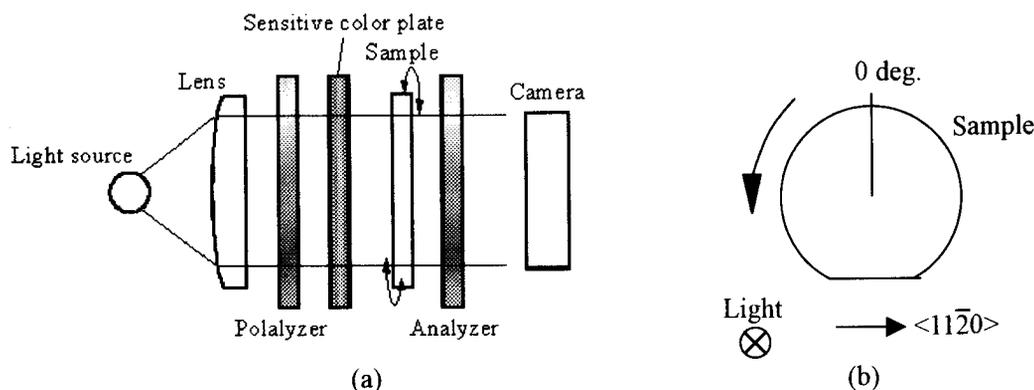
Fig.1 Schematic photoelastic method system

The samples were 2 inch 6H-SiC (0001) just wafers made by sublimation method. The wafer thickness was 1mm. Figure.1 shows the schematic system of photoelastic method. The source of light was the white light. The sensitive color plate was cellophane paper, whose retardation was about 500nm and color was orange. We observed the change of color by rotating the sample. If the sample has retardation about +200nm, the color-changed blue, if it has the retardation about -200nm, the color changed yellow. We can know which the force is compress stress or tensile stress from these results.

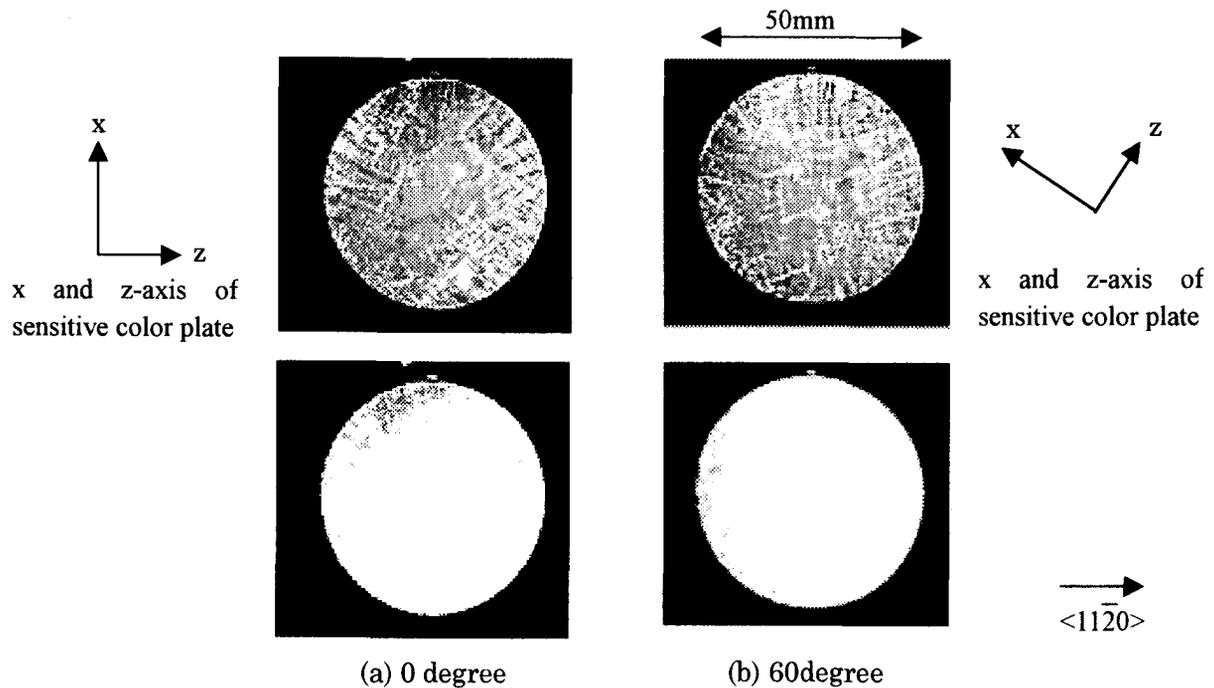
Fig.2 Photo elastic image of 2 inch SiC wafer. The upside images of (a) and (b) were changed to gray scale image, but almost area looked orange and downside images were extracted the violet area.

Fig.2 (a) and (b) show the photoelastic images whose wafers position were 0 degree and 60 degree, respectively. We decided the wafer position named 0 degree when the wafer positioned like fig.1 (b) and 60 degree means the wafer rotated 60 degree to counterclockwise direction. By comparing with fig.2 (a) and (b), we found the violet area moved to counterclockwise direction but the violet color of (b) became lighter than that of (a). It means the x-axis of sample (x-axis corresponded with the short axis of the ellipse) is $\langle 1-100 \rangle$ direction. This sample is compressed in x-axis direction. Normally the sample was influenced with compress stress along $\langle 1-100 \rangle$ direction and with tensile stress along $\langle 11-20 \rangle$ direction. And from fig.2, the color-changed area exist at peripheral area very much.

And we can observe easily stripes, which corresponded with sub-grain boundary. The crystal is closed to graphite crucible wall in sublimation method. So we think the one of the origins of the sub-grain boundary at peripheral area were the thermal expansions between graphite and SiC grown crystal[2].
