The Application of Optically-based NDE Techniques to Flaw Detection in Aircraft Components

D.J. Reid Rowland, D. Findeis, J. Gryzagoridis

University of Cape Town, Private Bag, Rondebosch, 7700, South Africa
dave_reid_rowland@hotmail.com, dfindeis@eng.uct.ac.za, profg@eng.uct.ac.za

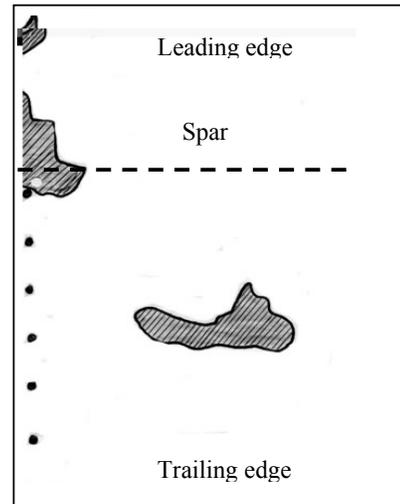
Figure 7 MIA scan of blade

Figure 7 shows a typical MIA scan, indicating the location of the spar and the leading and trailing edges and flawed regions.
